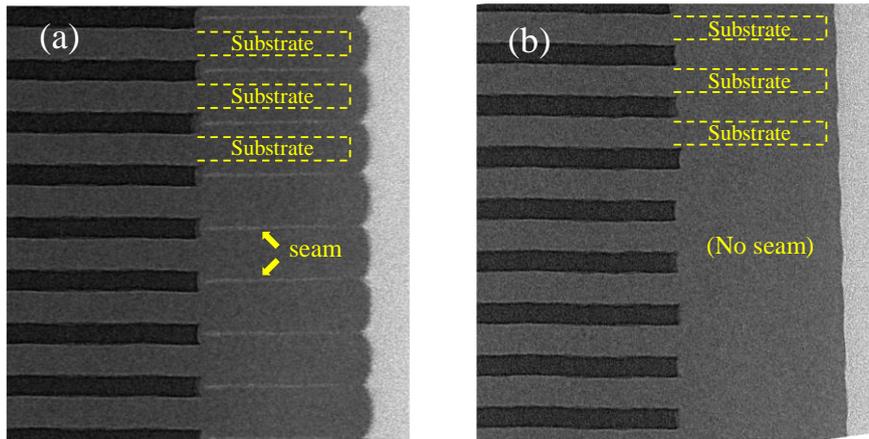
Figure 1 TEM images of lateral gap-fill using conventional thermal ALD. (a) Control group without the new process, where a clear internal seam is observed. (b) The new gap-fill process, showing that the seam is effectively eliminated.
