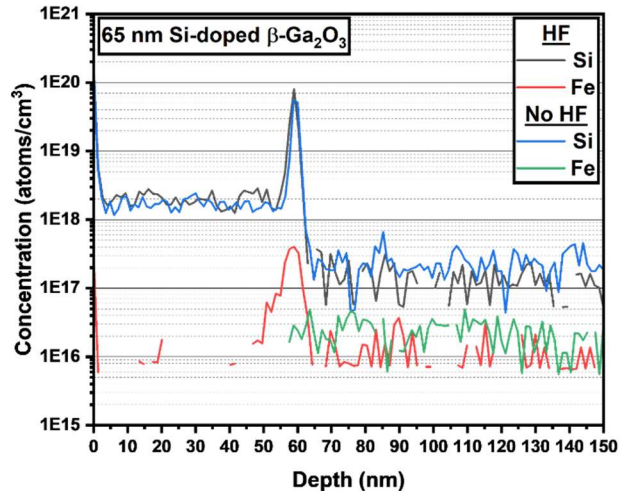
Figure 1 – SIMS results showing interfacial Si unaffected by HF etching in samples grow in our plasma-assisted MBE

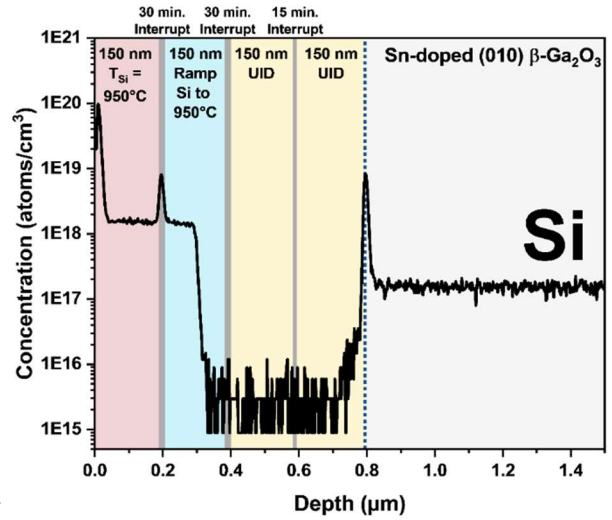
Figure 2 – SIMS stack testing for sources of unintentional Si doping. A hot Si source can cause Si re-accumulation in equal concentration to the interfacial contamination.

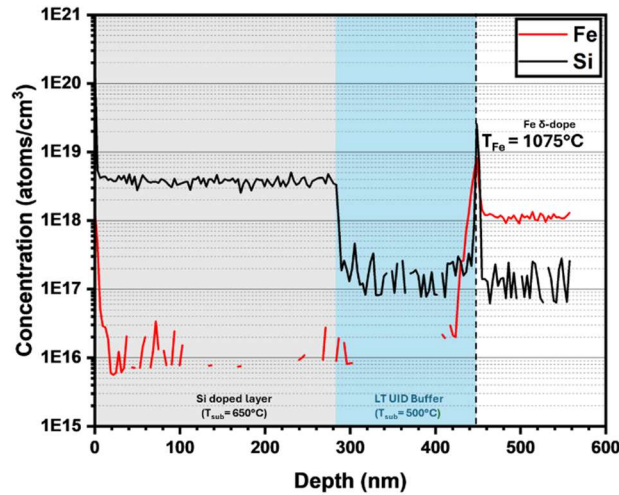
Figure 3 – SIMS results showing the Fe and Si doping profile within the two-layer growth process. Fe remains near the substrate interface.

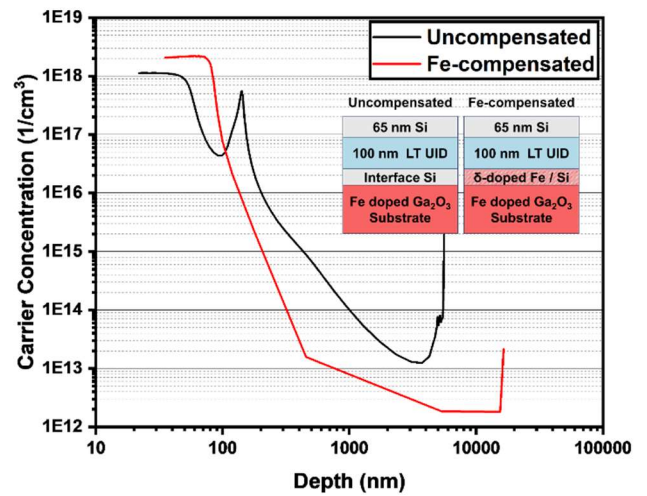
Figure 4 – C-V results showing no spike in carrier concentration near the substrate interface in sample with Fe compensation doping.

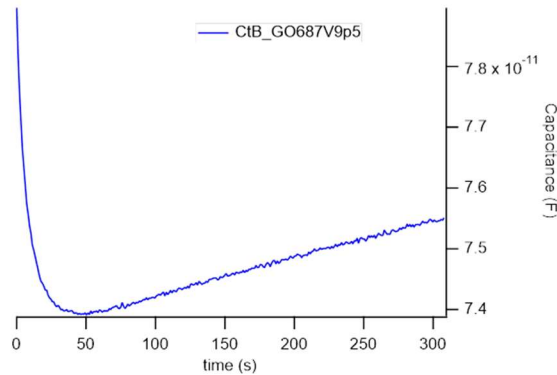
Figure 5 – Time-dependent C-V transients showing initial decrease due to acceptors followed by an increase due to donors.
