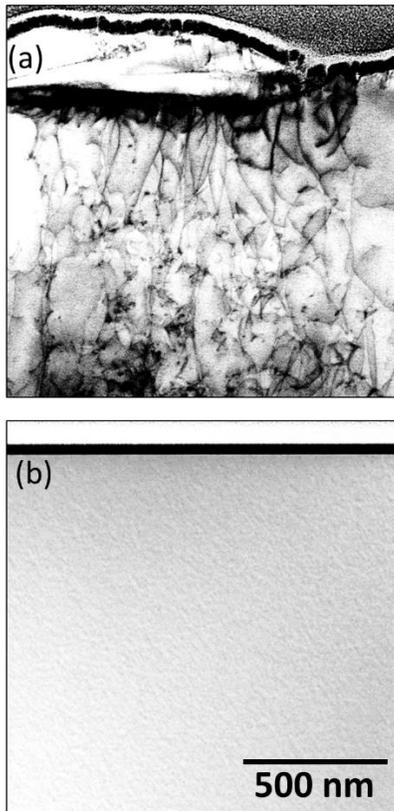
Figure 1. Bright field scanning transmission electron microscopy images of (a) as-received ground and (b) after CMP. The dark contrast corresponds to dislocations and cracks induced by the grinding processing, which are completely removed after polishing.

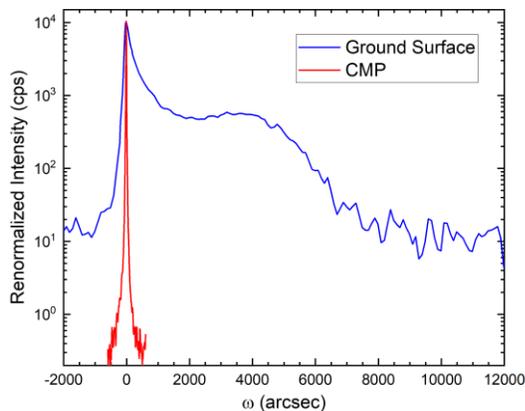
Figure 2. Triple-axis X-ray diffraction symmetric (020) β -Ga₂O₃ rocking curves for

the as-received ground surface (blue curve) and after CMP with colloidal silica (red curve). The FWHM and FW(0.001)M for the as-received ground surface were $\sim 180''$ and $\sim 8300''$, respectively, and $\sim 16''$ and $\sim 150''$, respectively, after CMP with colloidal silica. The low angle grain boundary at $\sim 4000''$ for the blue curve is due to lattice tilt induced by the grinding process.

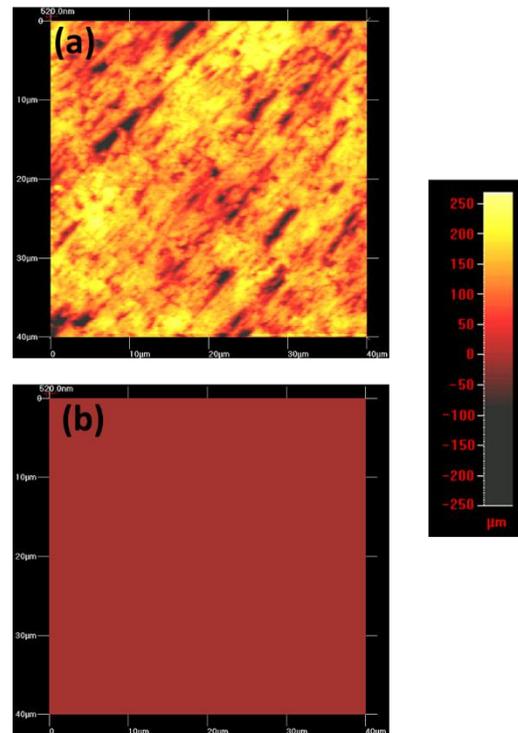
Figure 3. $40 \times 40 \mu\text{m}^2$ representative atomic force microscopy images of the surfaces for (a) as-received ground state (rms roughness $\sim 60 \text{ nm}$) and (b) after CMP with colloidal silica and cleaning with dilute bleach and citric acid (rms roughness $\sim 0.5 \text{ nm}$).
