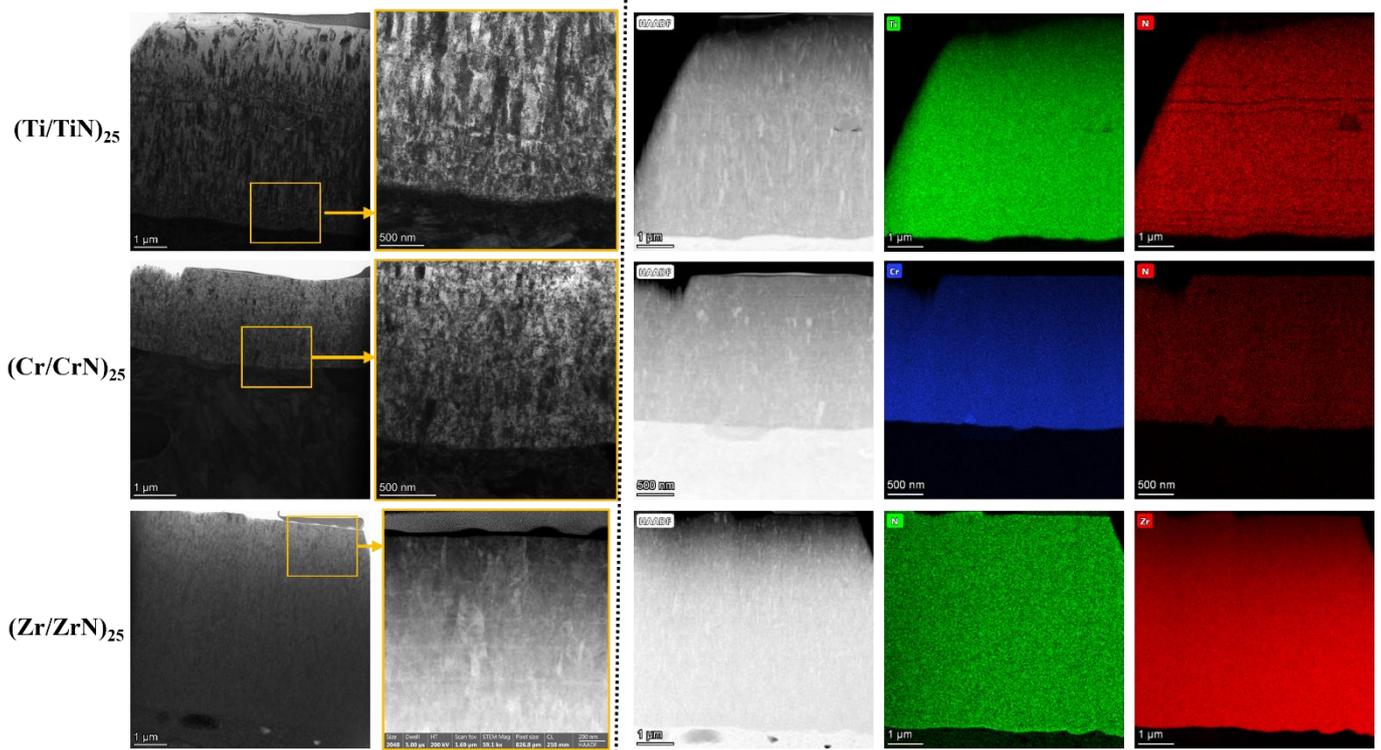
TEM cross-sections with EDS analysis of investigated coatings

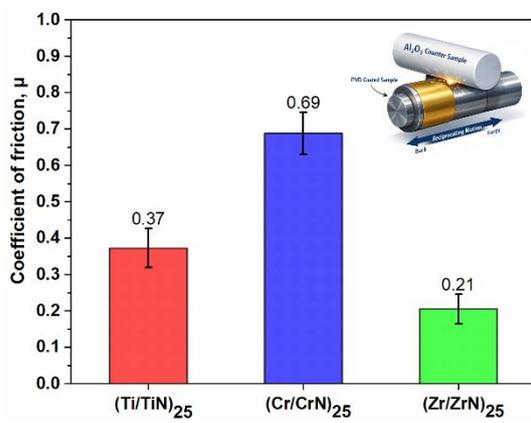
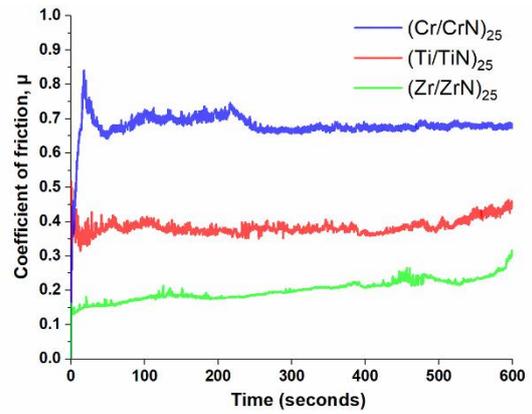
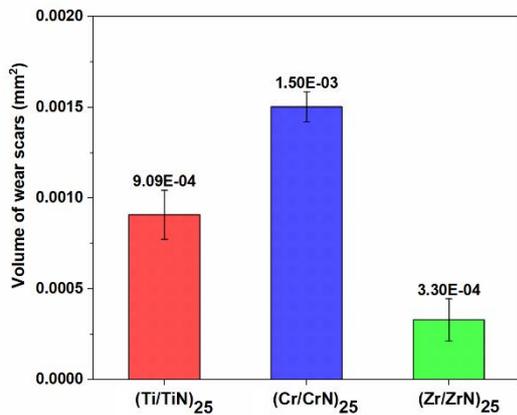
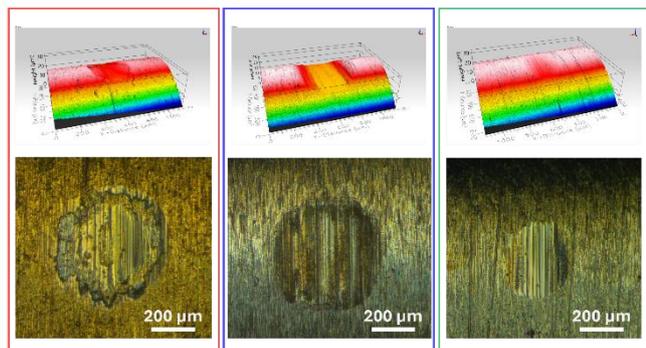
Results of reciprocating wear tests
